MORRO BAY WATERSHED STEELHEAD RESTORATION PLANNING PROJECT

STREAM INVENTORY REPORT

**CHORRO CREEK, 2001**

Prepared to:  
Coastal San Luis Resource Conservation District

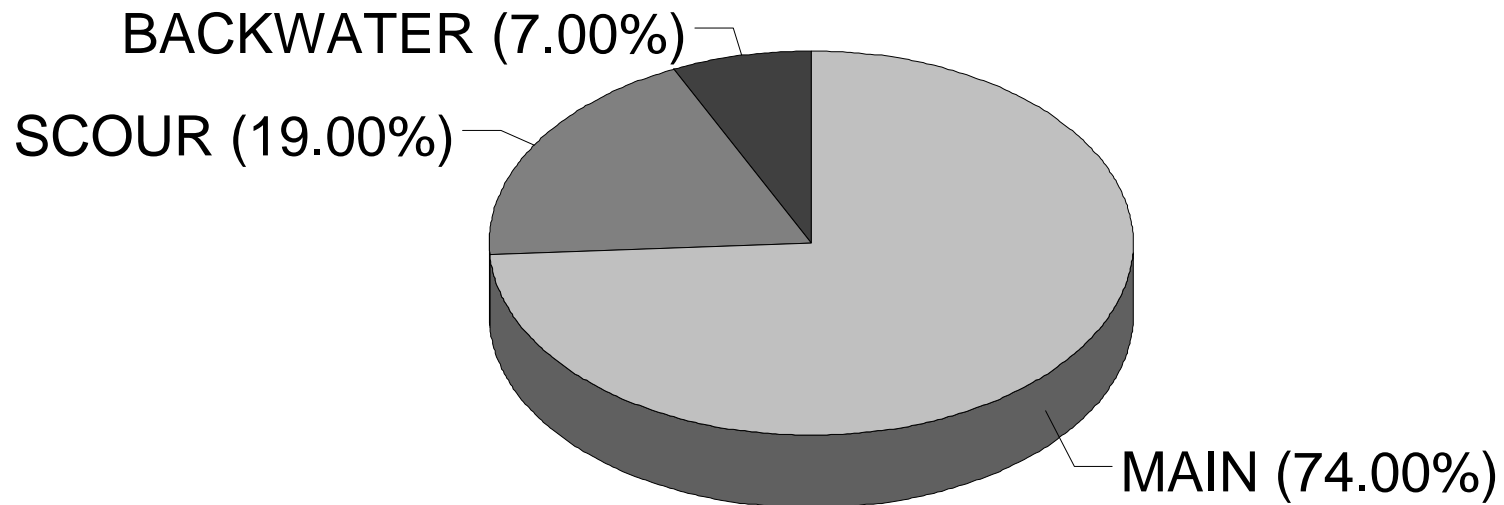
GRAPH 4

A total of 241 pools were identified (Table 3). Main-channel pools were most frequently encountered at 74% and comprised 82% of the total length of all pools (Graph 4).
